Release Summary

(AccoTestSTS8200CROSSVersion1100build220419_r p2.0)

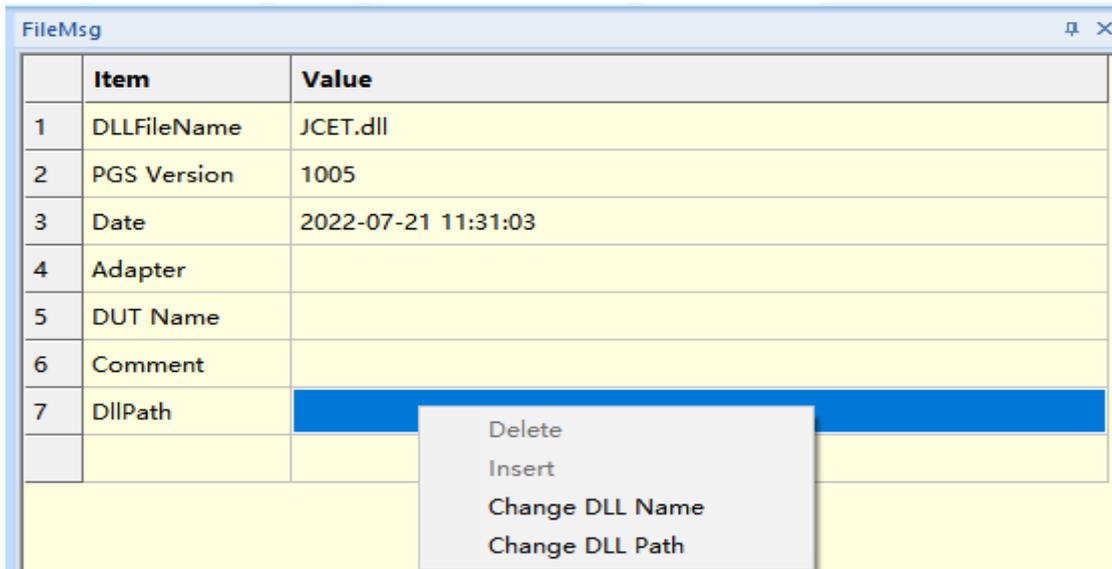
8. PGSEdit 3.0 add DLL path setting

Description: Add DLL path setting. Need to set the full path of DLL file. Directly load the DLL under this path。PGS needs to be upgraded to version 1005.

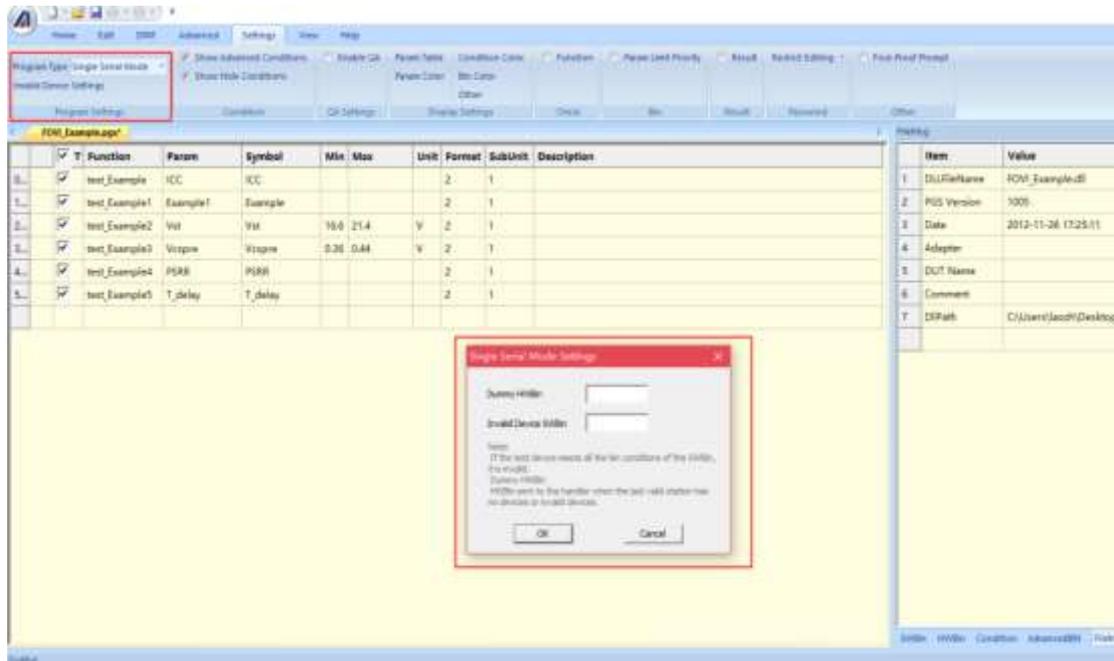
9. Add Single serial Mode

Description: Add SingleSerialMode. For single sot Mutil-Station. Please refer to the user manual of AccoTEST SYSTEM Software for details.
